ORNL/TM-8859

**Committee's Report on Ruthenium  
Fall-Out Incident**

Formerly issued as an internal report  
January 25, 1960

## REPORT OF THE COMMITTEE ON THE RUTHENIUM FALL-OUT INCIDENT

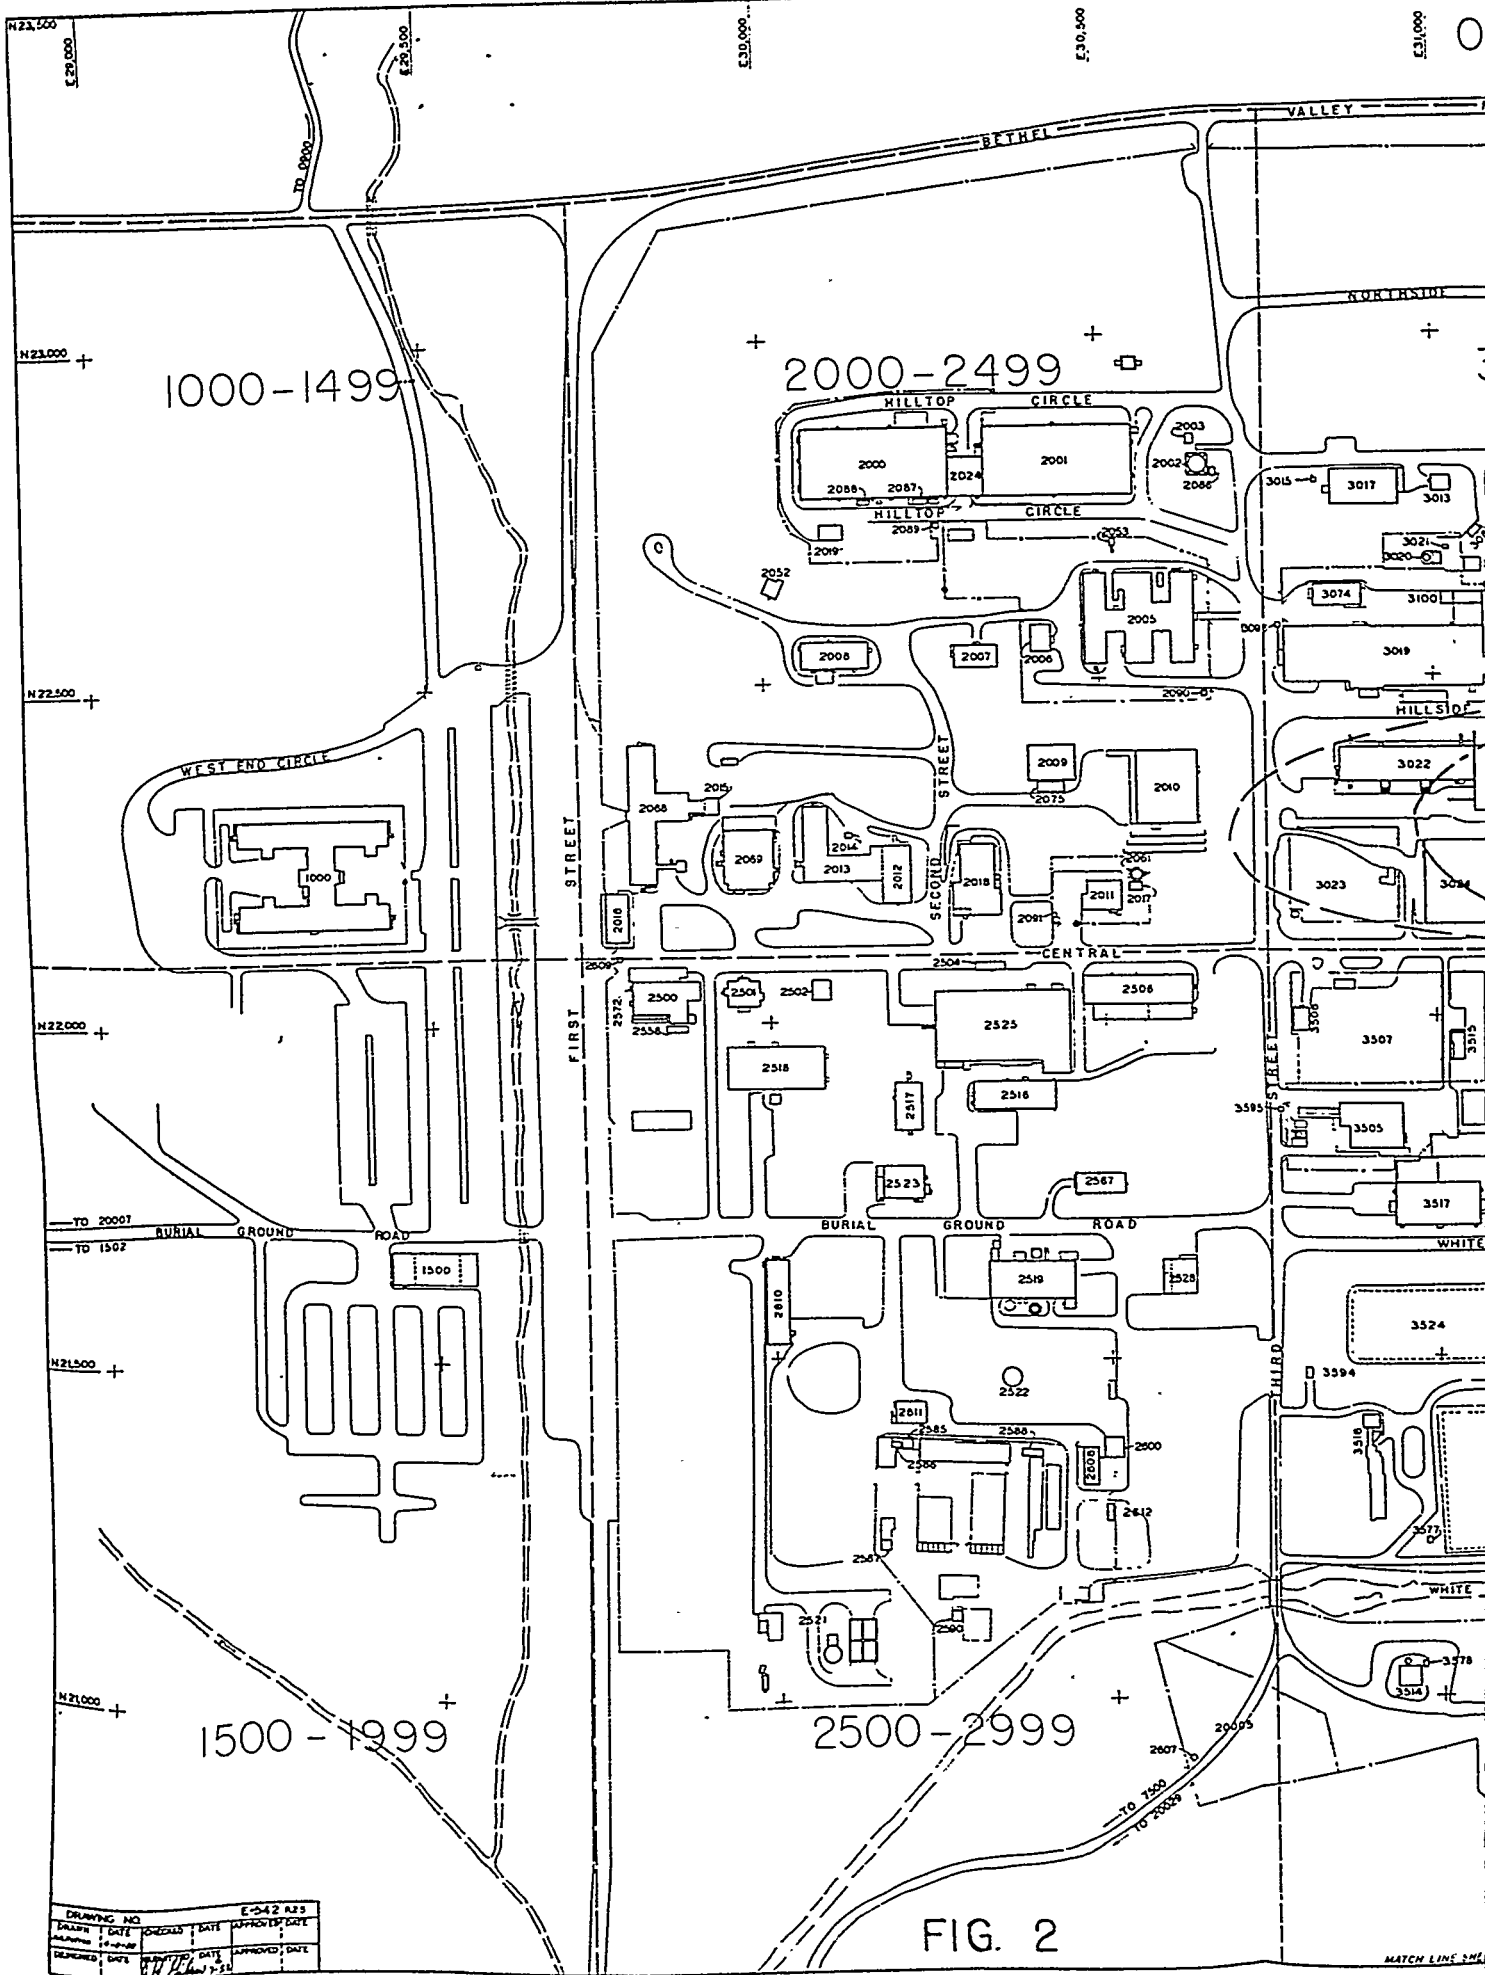
FIG. 2

Numbers associated with contour lines represent a rough average of readings in mr/hr taken with a G.M. survey meter at grass top level in the areas indicated. Some isolated spots of intensity higher than shown could be found throughout the contaminated area.
